ROOF MRI

PLACE OF WORSHIP

1234 SPIRITUAL BLVD | MYTOWN, USA

DATE: MARCH 3RD, 2025

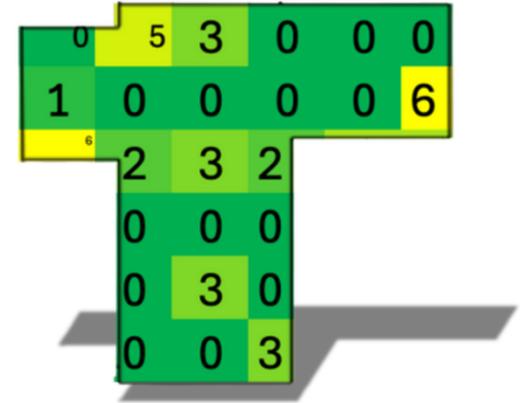
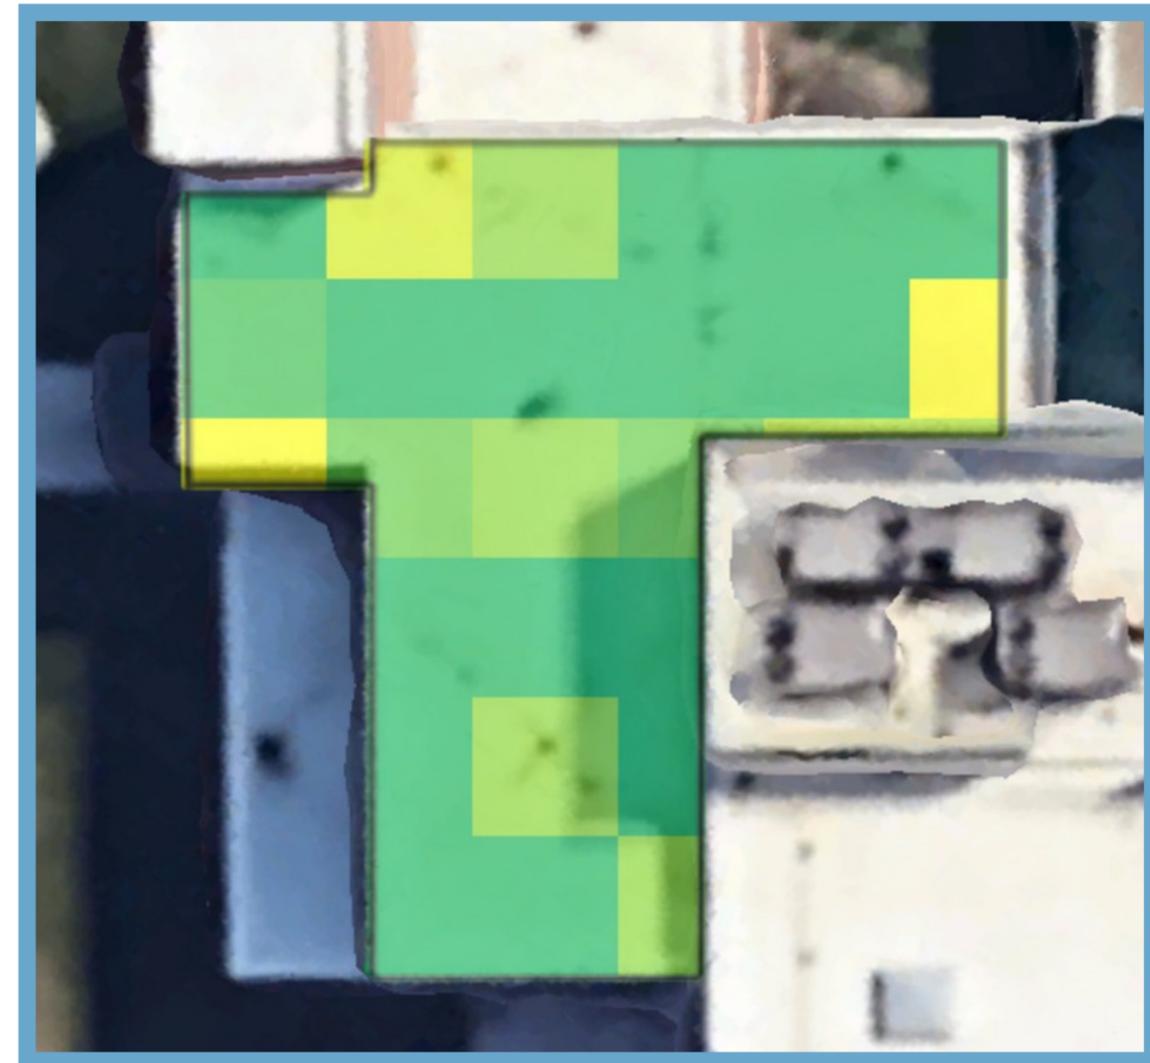
PLACE OF WORSHIP | ROOF 1

MOISTURE ANALYSIS:	SATURATED 0SF	(0%)

DAMP 300SF	(11%)

DRY 2400SF	(89%)

The results of the scan on this TPO roof indicate that 11% of the roof is conclusively damp to wet. There are some early warning signs of moisture infiltration that should be addressed to preserve the life of the membrane.

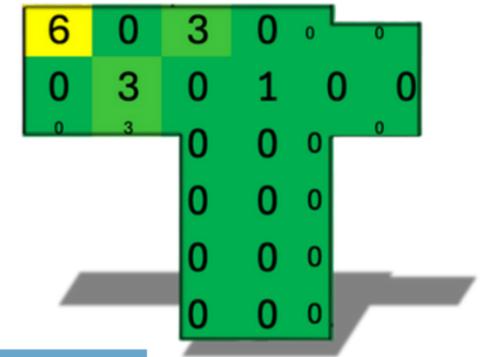
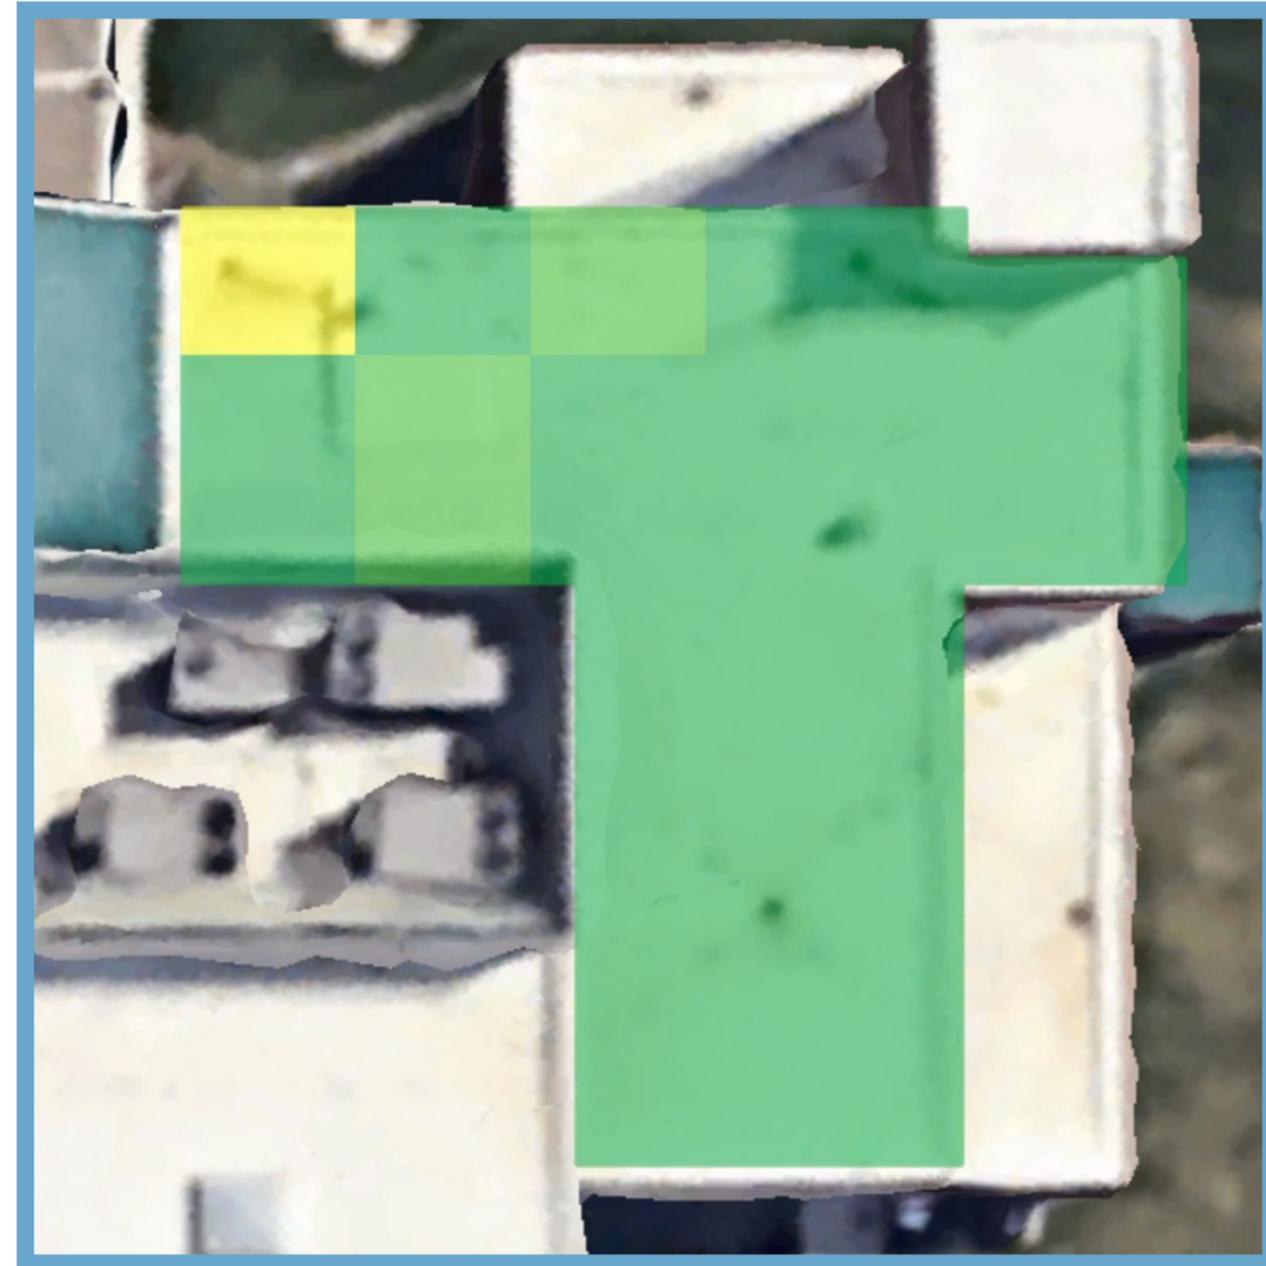
PLACE OF WORSHIP | ROOF 2

SATURATED 0SF	(0%)

DAMP 100SF	(4%)

DRY 2600SF	(96%)

The results of the scan on this TPO roof indicate that % of the roof taking on moisture in one area. The percentage is not high, but based on the current situation with the rest of the roof it is worth monitoring.

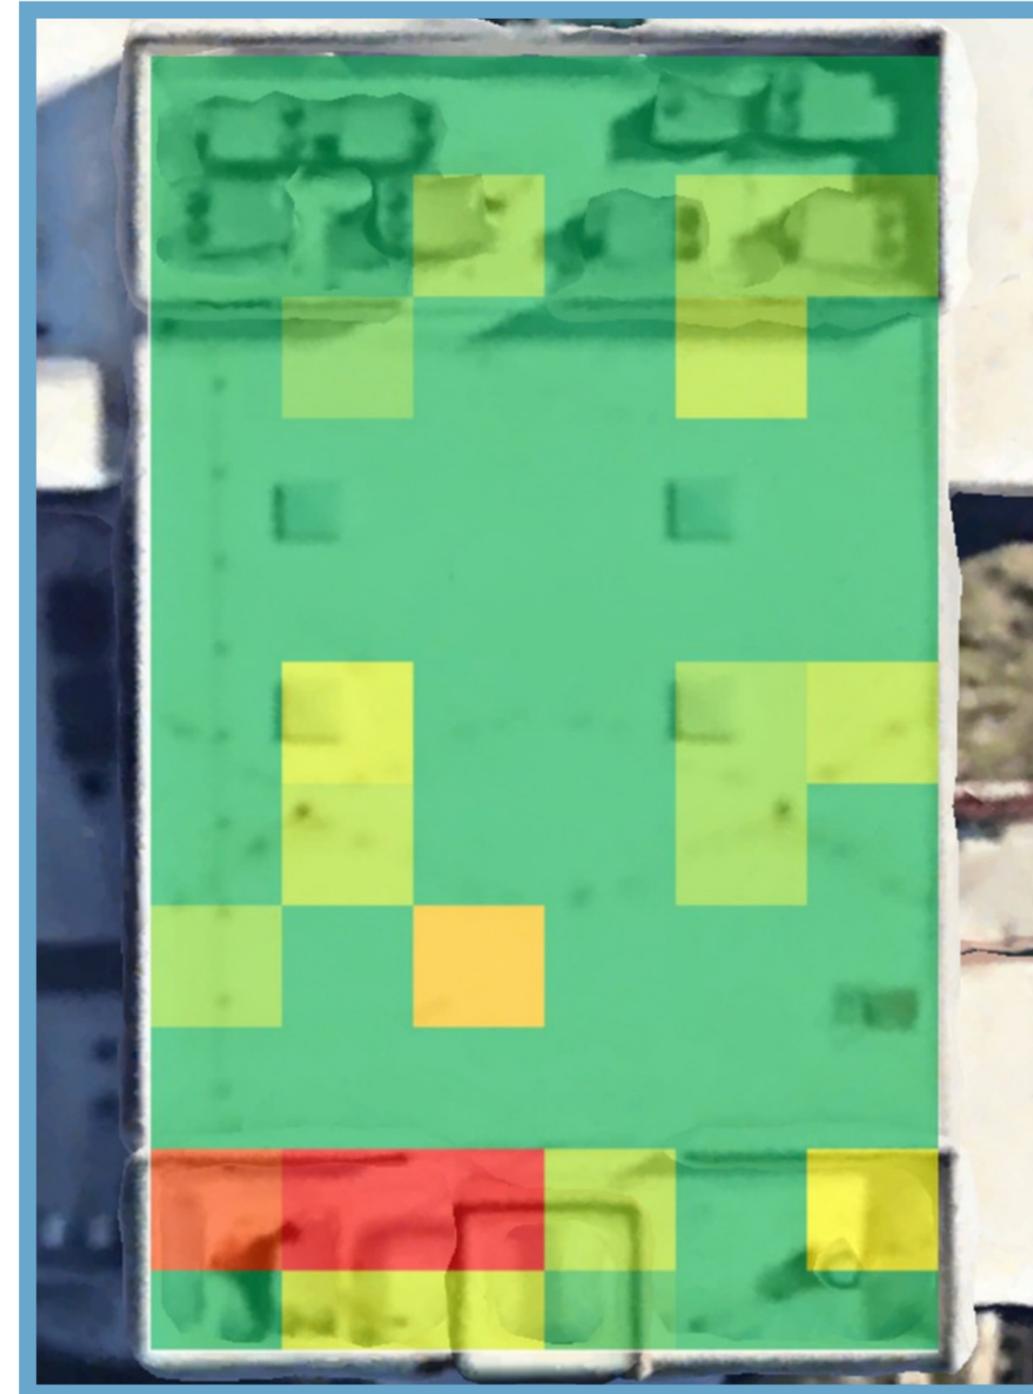
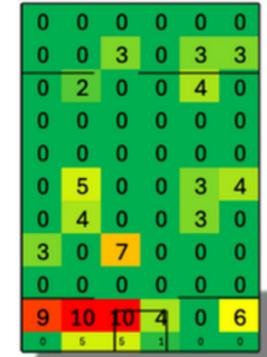
PLACE OF WORSHIP | ROOF 3

SATURATED 0SF	(5%)

DAMP 100SF	(8%)

DRY 2600SF	(87%)

The results of the scan on this TPO roof indicate that 13% of the roof taking on moisture and the areas are not localized. This percentage is high enough to raise concerns, along with the membrane showing signs of early deterioration. Maintenance is imperative for this system.

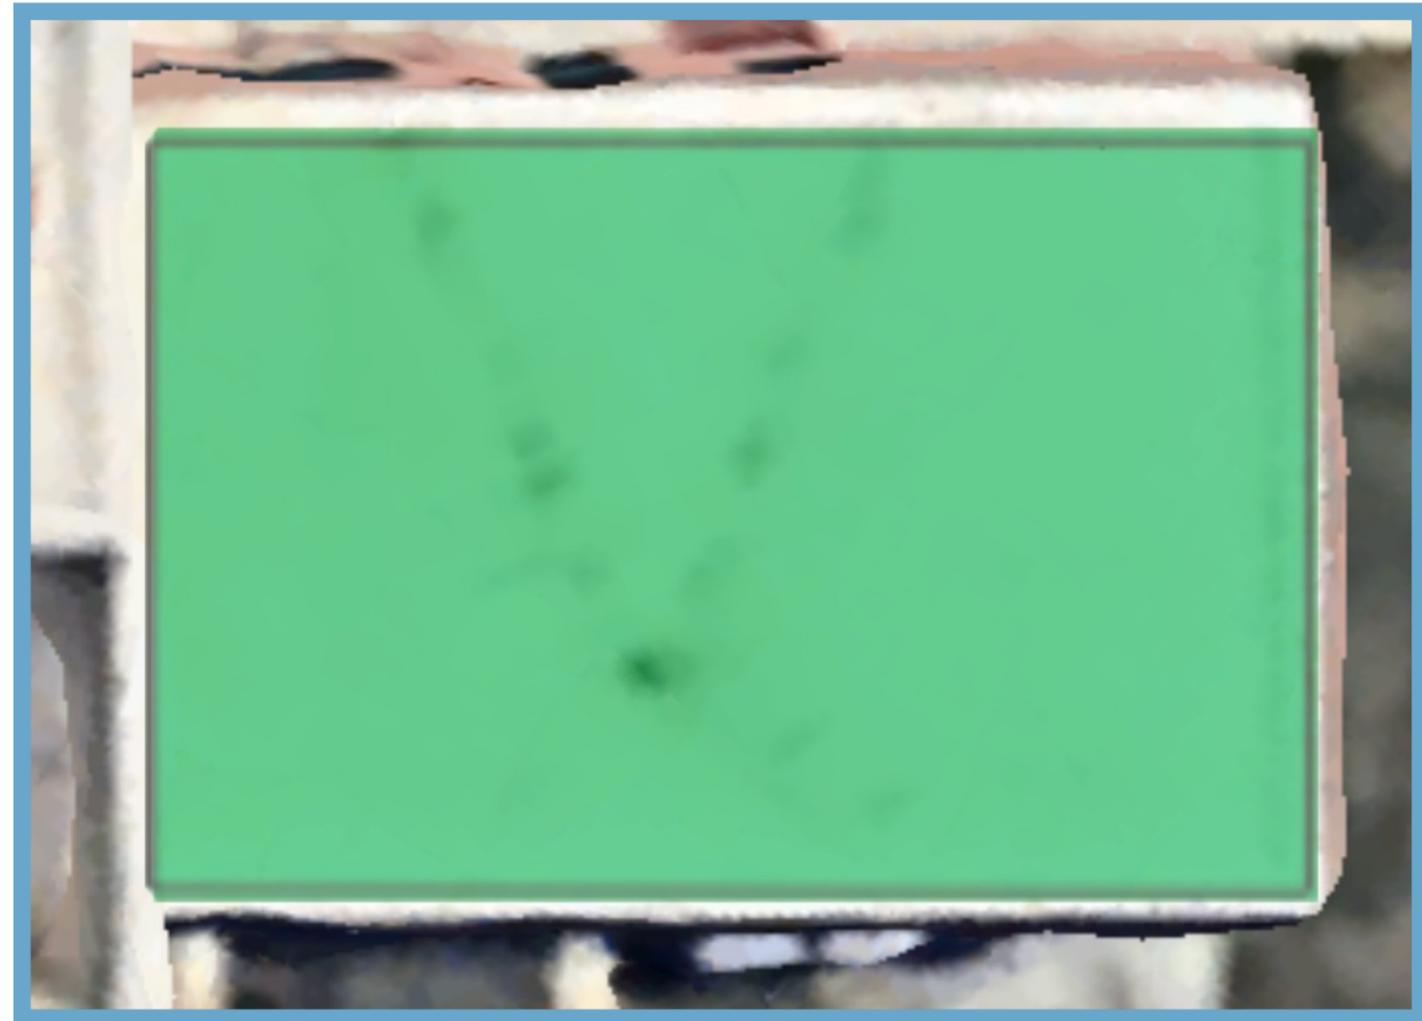
PLACE OF WORSHIP | ROOF 4

DRY 1500SF	(100%)

The results of the scan on this TPO roof indicate that this roof is performing as it should be expected for its age.
