ROOF MRI

Inspected By: **REDRY**

1234 COMMERCIAL DR. | NASHVILLE, TN

METHOD(S): **ROOF MRI**
PIN PRICK + IMPEDANCE

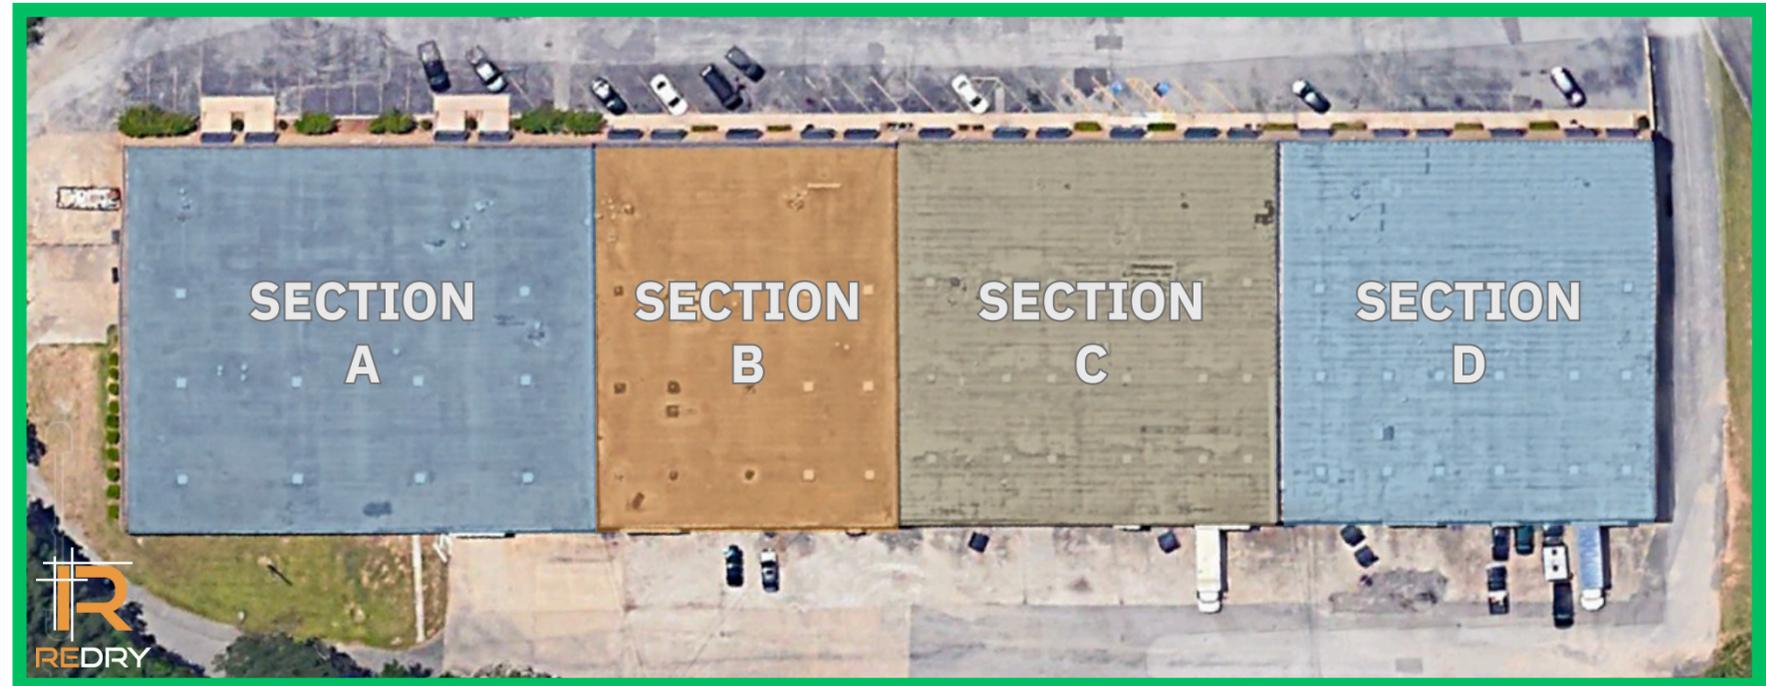
INDUSTRIAL | SECTION D

TOTAL SQUARES: 196 | 100SF EACH

MOISTURE ANALYSIS: SATURATED | 700SF (4%)

DAMP | 700SF (4%)

DRY | 16,400SF (83%)

UNDETERMINED | 1800SF (9%)

The results of the scan on this gravel surfaced BUR roof indicate that only 12% of the roof is conclusively damp to wet. The issues appear to be mostly focused around the flashing and not in the field.

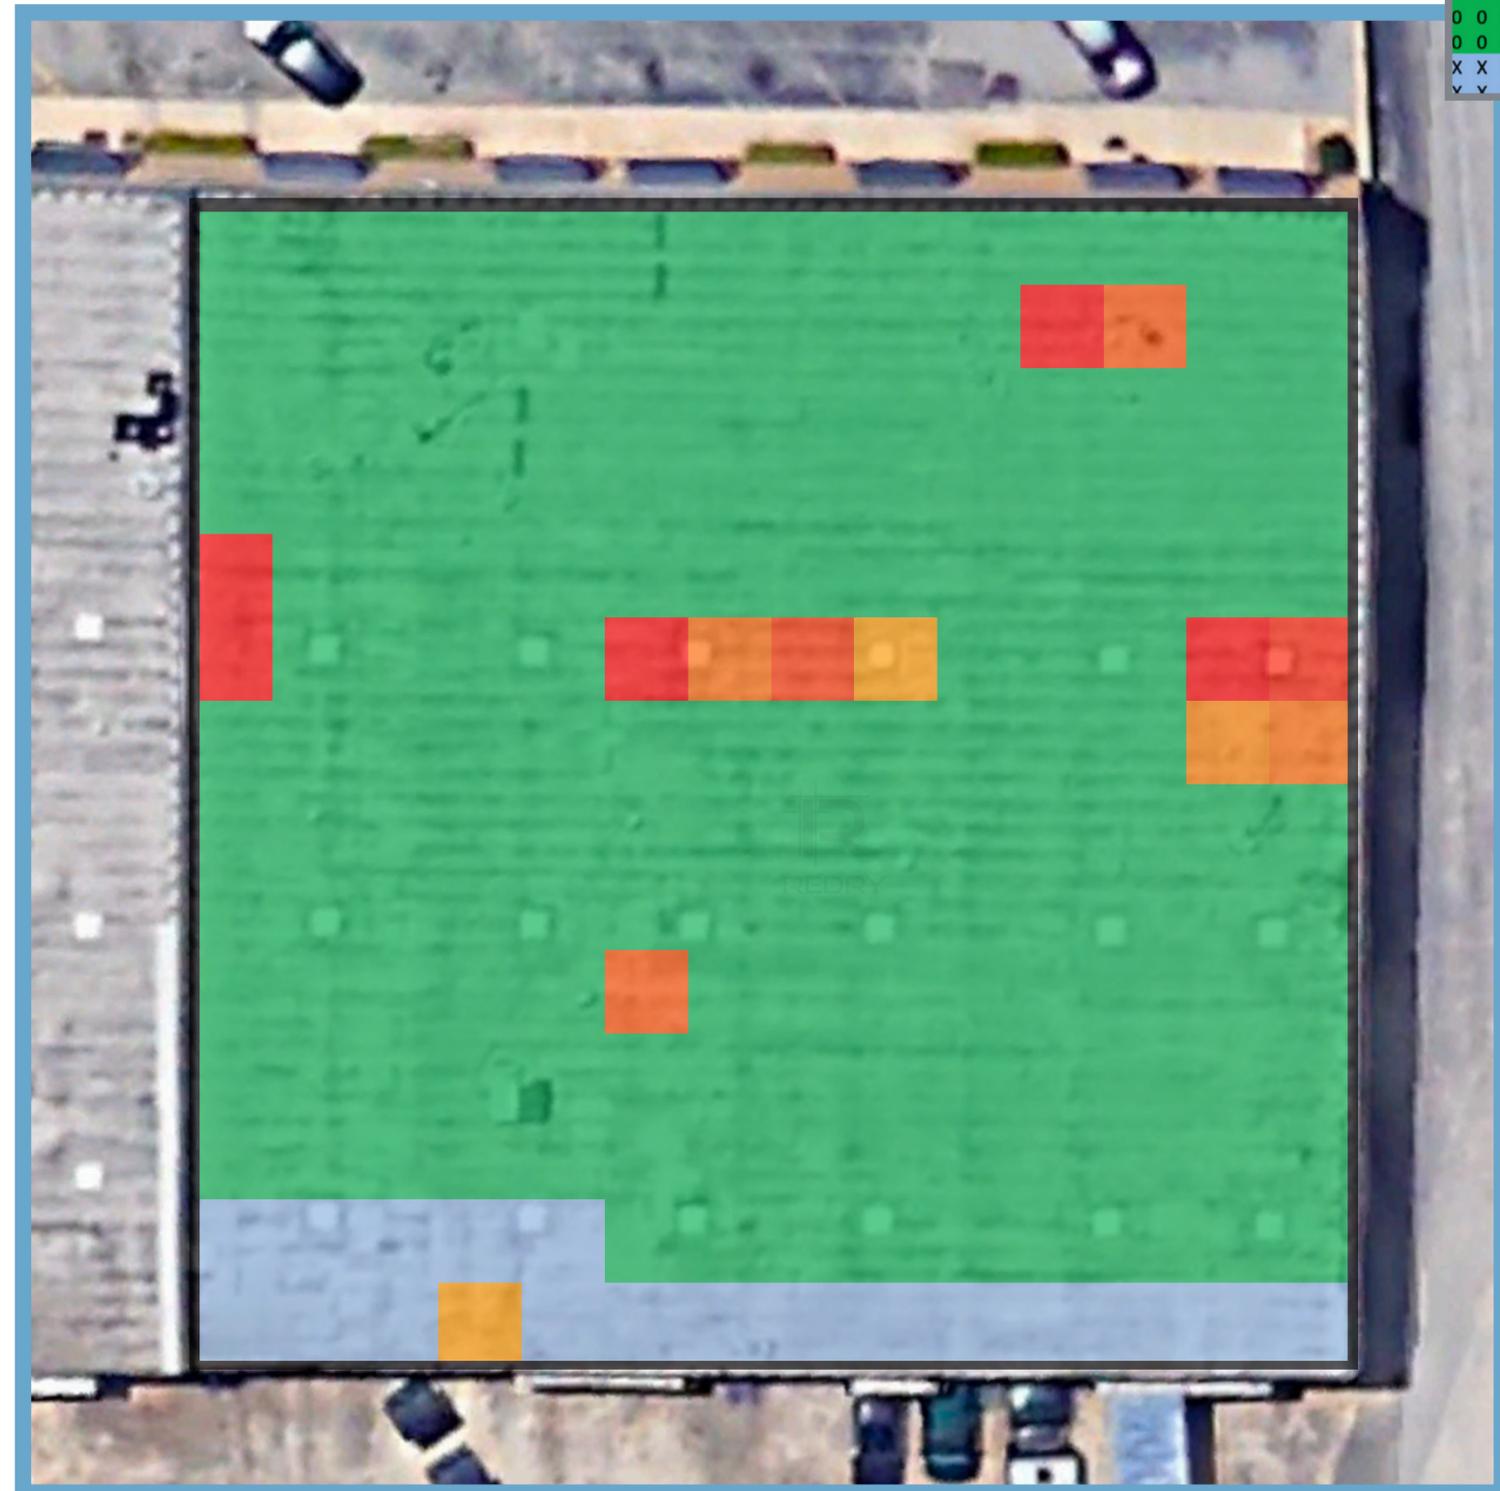
MAKES SENSE | INDUSTRIAL

TOTAL SQUARES: 784 SQ | 100SF EACH

MOISTURE ANALYSIS: SATURATED | 2200SF (3%)

DAMP | 2700SF (4%)

DRY | 68,000SF (86%)

UNDETERMINED | 5500SF (7%)

COMMENTS: There are areas of the roof that need to be addressed. The decking appears to be gypsum and can deteriorate under wet conditions.

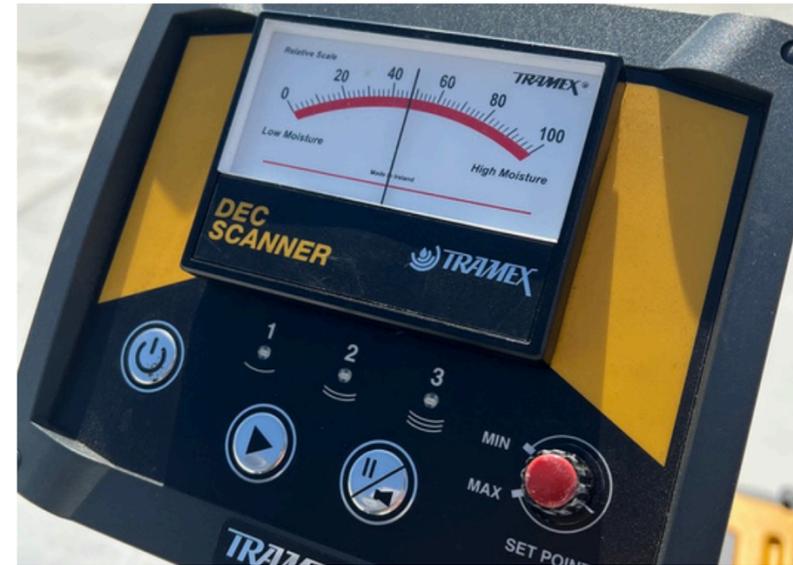
ReDry LLC used the most professional equipment and methods to locate and confirm moisture percentages. A Tramex DecScanner was utilized to detect moisture without penetrating the roof system. Using an Impedance Scanner is one of the primary ways to detect moisture in roofs and walls without penetrating the roof.

A Tramex MEX5 moisture probe was utilized to confirm moisture readings and to calibrate the Tramex. This is a preferred method for ensuring the non-destructive testing is as accurate as possible. Test is in accordance with ASTM Standards for non-destructive testing.
