ROOF MRI

PLACE OF WORSHIP

1234 SPIRITUAL BLVD | MYTOWN, USA

DATE: MARCH 3RD, 2025

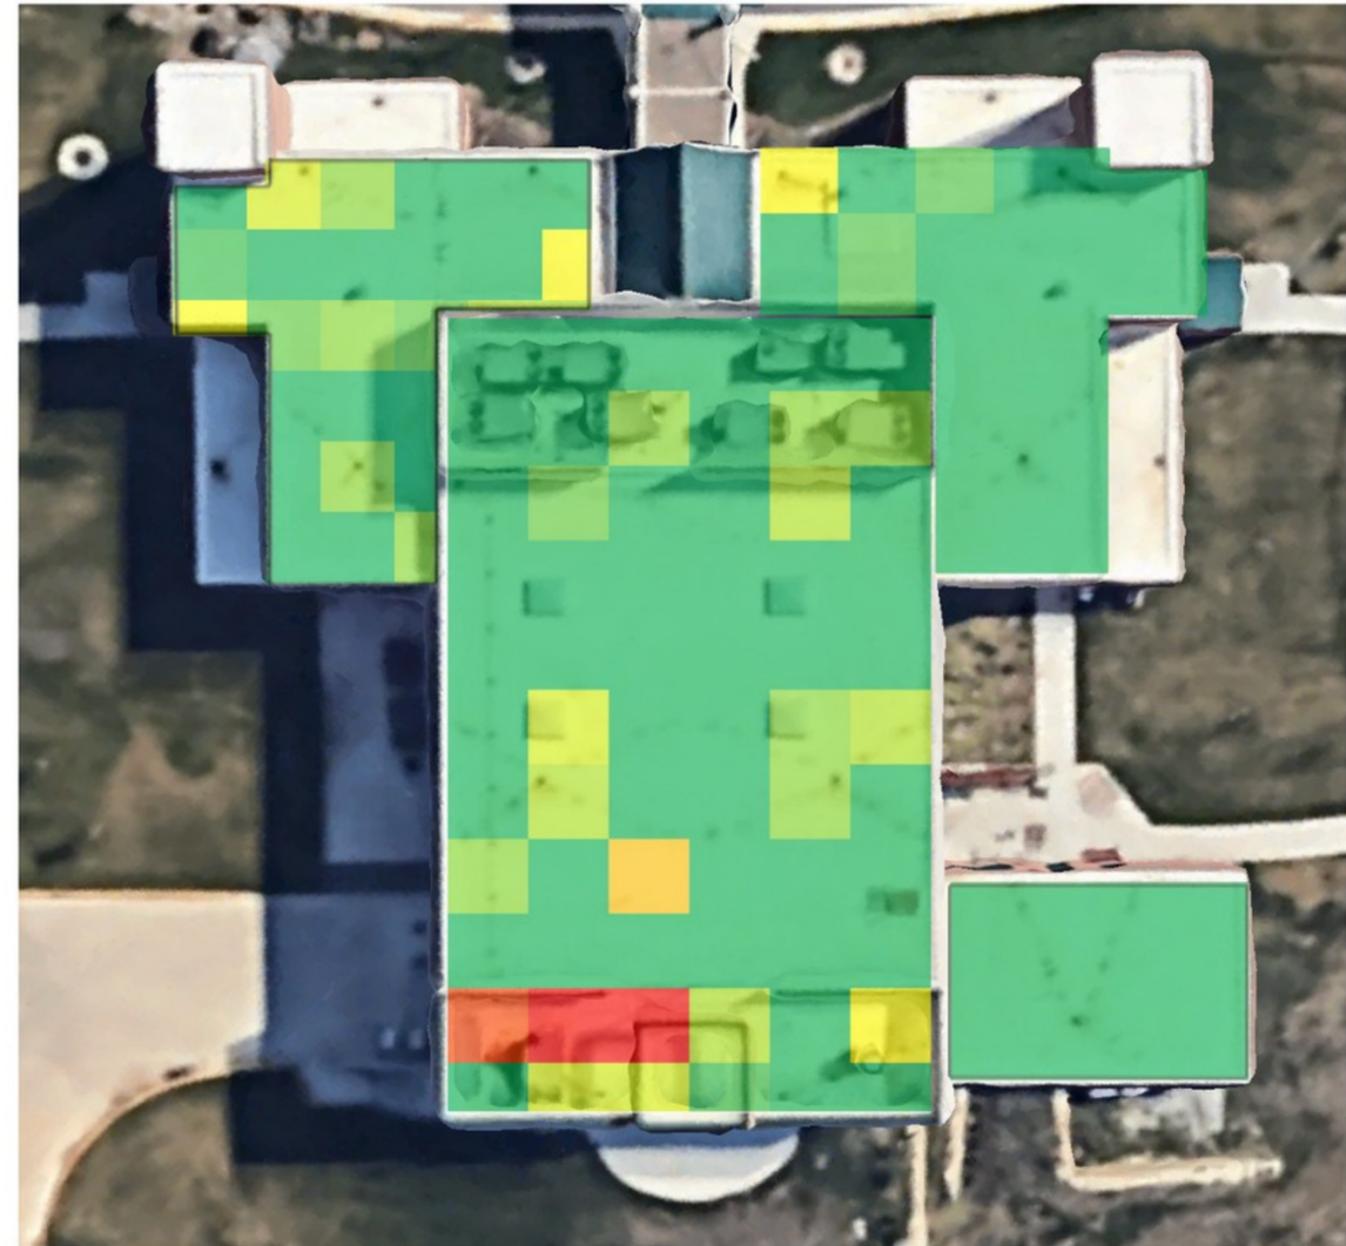
PLACE OF WORSHIP | ROOF 1

MOISTURE ANALYSIS:	SATURATED 0SF	(0%)

DAMP 300SF	(11%)

DRY 2400SF	(89%)

UNDETERMINED 0SF	(0%)

The results of the scan on this TPO roof indicate that 11% of the roof is conclusively damp to wet. There are some early warning signs of moisture infiltration that should be addressed to preserve the life of the membrane.
